# GRAVITY GRADIENT STABILIZATION SYSTEM for the

APPLICATIONS  
TECHNOLOGY  
SATELLITE

## SIXTH QUARTERLY PROGRESS REPORT

SIXTH QUARTERLY PROGRESS REPORT  
FOR THE  
APPLICATIONS TECHNOLOGY SATELLITE  
GRAVITY GRADIENT  
STABILIZATION SYSTEM

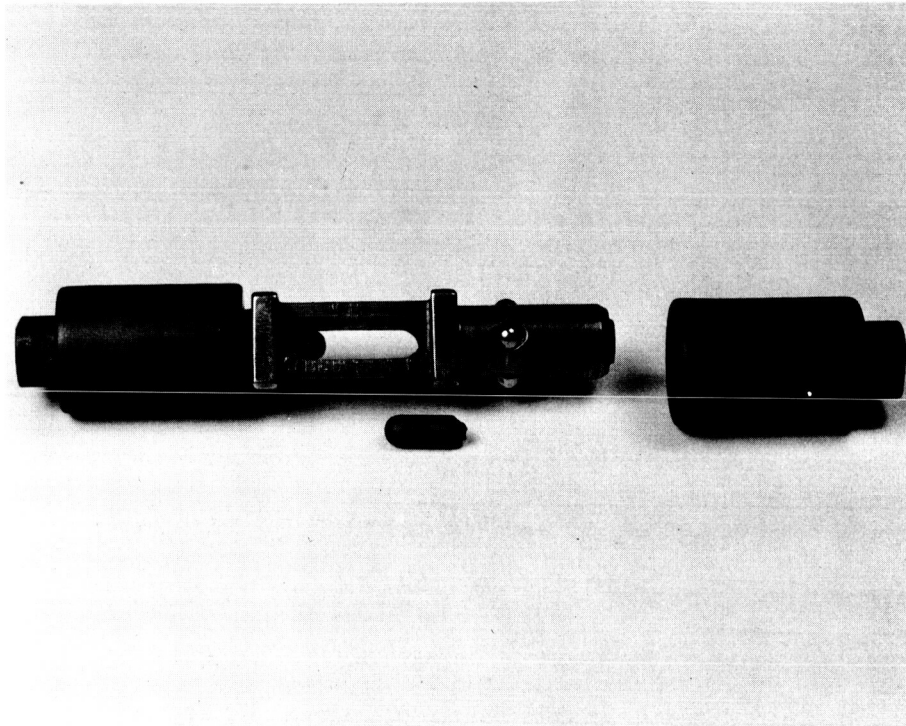
Figure 3-1. Avdel Ball-Lock Mechanism

Two Avdel ball-lock mechanisms were used during the tests. Each mechanism was subjected to one single and one double squib/thruster firing. The mechanism subjected to a single firing first showed no visible abnormal spindle damage after the first firing, but sustained one broken spindle (as seen in Figure 3-1) during the second (double) firing. This mechanism also underwent two mechanical releases at deHavilland prior to shipment of the T-1 Damper Boom Assembly. The mechanism subjected to a double firing showed no visible abnormal spindle damage after the first firing but sustained two broken spindles during the second single firing. The spindles from both of these expended ball-lock mechanisms are presently under analysis. Consideration is being given to treating this mechanism as a "one-shot" device, similar to the squib/thruster, and concurrently a spindle material change is being investigated to ensure that the spindles will be intact after this "one-shot."

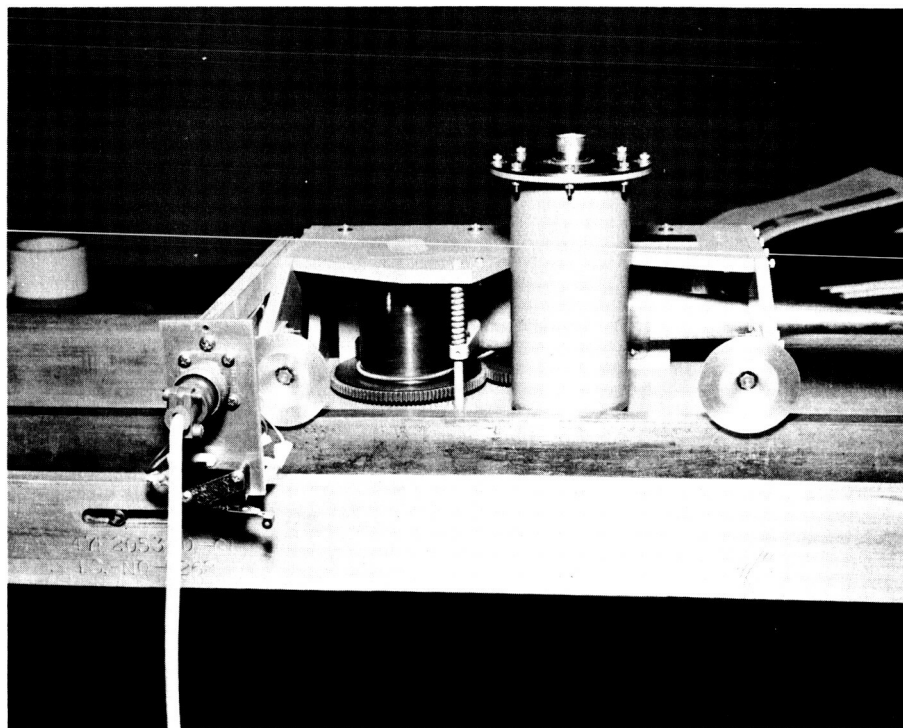
Figure 3-12. Boom Take-up Mechanism

Initial performance tests were hampered when slight missynchronization of take-up and extension motor speeds resulted in loading of the boom tape, rather than loading on the wheel-borne take-up mechanism. This problem with the test equipment was overcome when the nylon wheels, provided by the manufacturer, were replaced with the ball bearing mounted, stainless steel wheels shown in Figure 3-12.

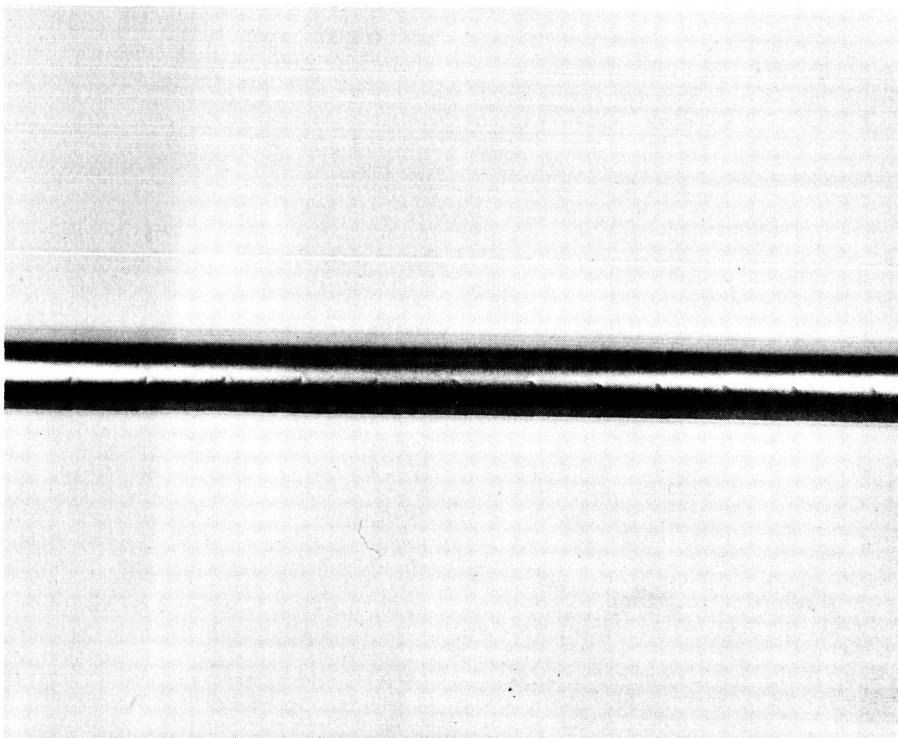
Figure 3-19. Boom Wrinkle Pattern

Inspection of the deployed portion of both booms reveals a regular pattern of creases starting at the erection unit and gradually decreasing in severity until they disappeared at approximately 20 feet away from each erection unit. The patterns can be seen developing in the guidance as shown in Figure 3-18. These patterns suggested the possibility of a condition of unnatural deployment developing on both booms, which gradually worsened as more boom was deployed. Figure 3-19 shows a typical length of this pattern on an erected boom. Disassembly of the unit subsequent to the above failure revealed the following:

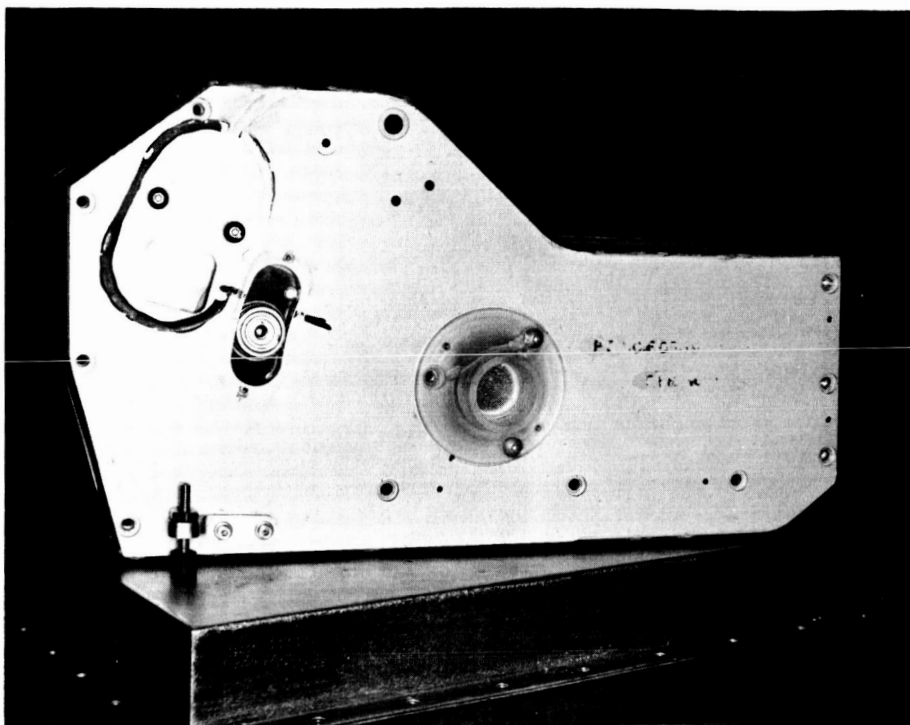
Figure 3-20. Side View of Erection Unit Showing  
Bearing Hang-up

- a. The storage drums of both booms were found to be hung-up in the kidney slots in a position consistent with zero extended boom length. Figure 3-20 shows a side view of the erection unit with the storage drum bearing in a "boom-deployed" condition. The line at the edge of the kidney slot is the position of the bearing center in the "hung-up" condition. Figure 3-21 is a close-up of the condition immediately after disassembly and shows the approximately 0.15-inch displacement between the point of hang-up and the position of the bearing that corresponds with a boom deployment of 56 feet.

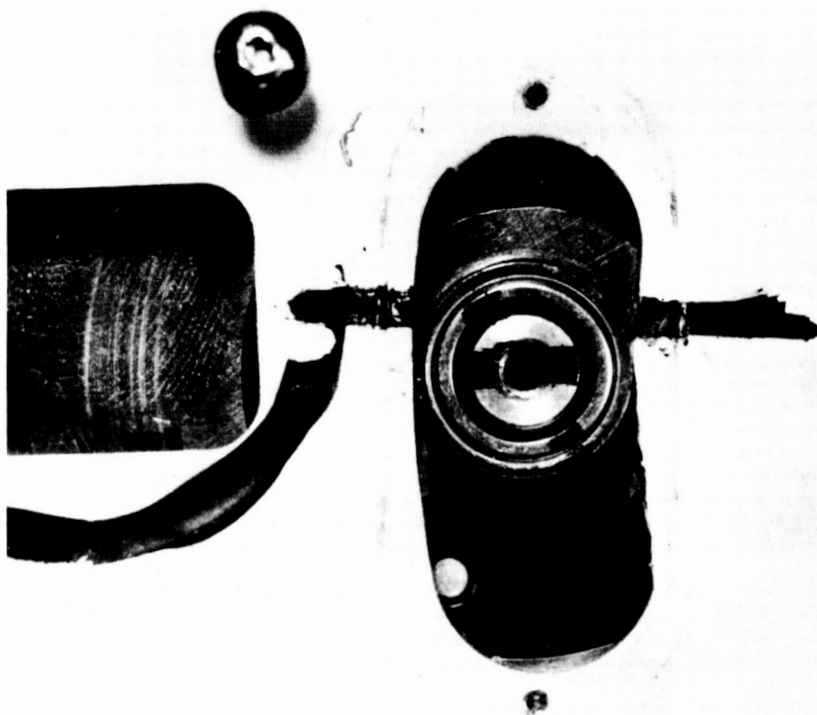
Figure 3-21. Close-up of Bearing Hang-up

- b. The thin spacer under the bearing flange (visible in Figure 3-22) was found to be badly deformed in the area where it is contacted by the bearing flange.
- c. A bearing stress failure of the side plate material was found in the area just under the bearing flange (in booms-stowed position). Fretting corrosion is also visible in the area contacted by the spacer (See Figure 3-22).
- d. This bearing stress failure was found to have moved metal in a feather-edge fashion into the kidney slot, thereby reducing its width (See Figure 3-23). This reduction in bearing slot width was found to restrict motion of the bearing along the kidney slot, resulting in the hang-up.
